Inspection Report

Property Address:
7355 E. Anywhere Dr
Kansas City, MO MO 64114

Holmes Inspection Company

Date: 11/12/2013	Time: 02:14 PM	Report ID: Sample JG
Property: 7355 E. Anywhere Dr Kansas City, MO MO 64114	Customer: Billy Bob	Real Estate Professional: Janet Goss Platinum Realty

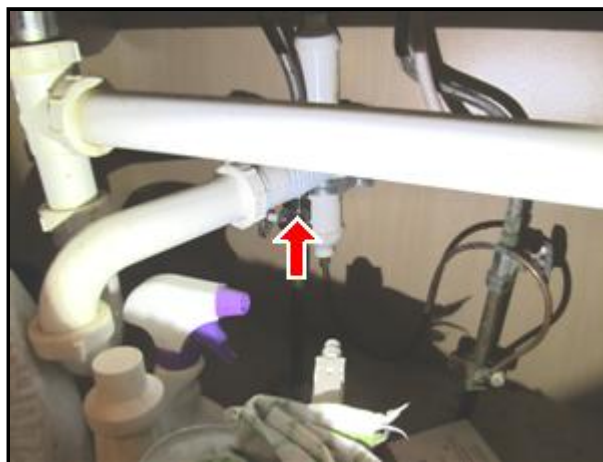
1.1 Picture 1

One or more of the pipes under the sink have rust or corrosion.

There is an improper "accordion" type drain line under the sink. Drain lines are to be smooth bore so they don't trap hair, soap, etc and over time slow down or clog drains. at the sink. You may want to change or modify this.

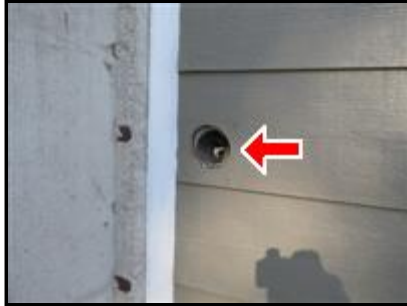
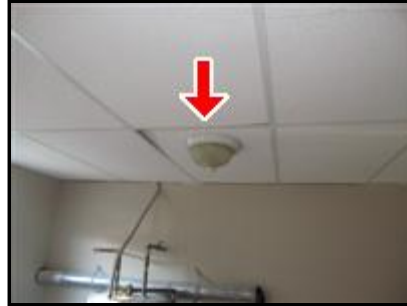
- Exterior back-vent damper for dryer vent missing.
- No switch for laundry room found and light off.

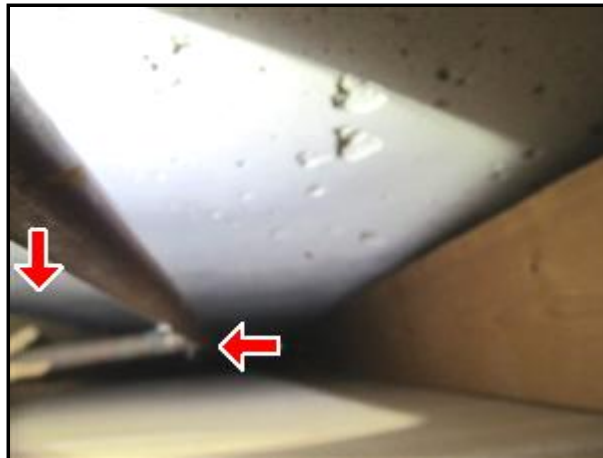
3.0 Picture 1

Improperly covered up by sheetrock and behind laundry wall / not accessible.

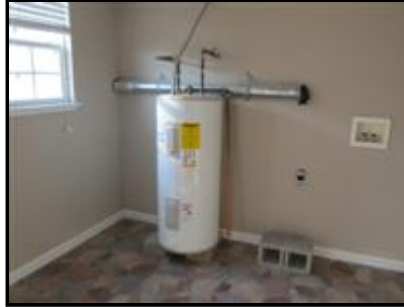
3.5 Picture 1

FYI - The electric water heater did not have a disconnect within eyesight NOR a lock-out breaker at the electric panel. Current building standards recommend this feature for safety when servicing the unit. The new owner may want to install this as an improvement or upgrade.

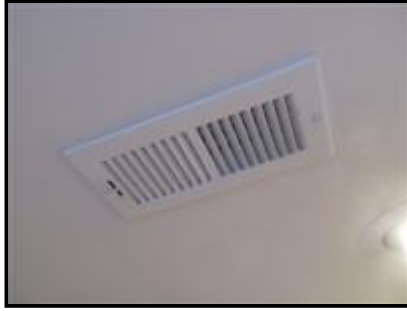
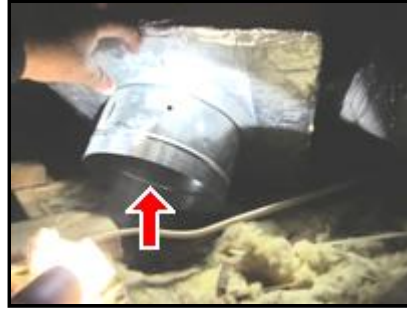
- There were habitable rooms at the 2nd floor with no heat source and/or the heat runs open in attic (not completed).

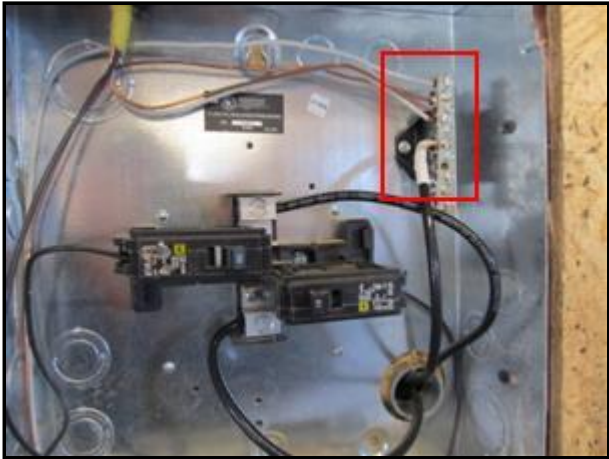
5.2 Picture 1 Garage Sub-Panel

During the examination of the electrical panel(s) we noted deficiencies, such as the following conditions:

- Neutral and ground wires were improperly installed on the same buss bar at the garage sub-panel. In case of a short, this can allow electricity to go in multiple directions and is a safety hazard.
- Unprotected opening(s) / missing wire clamps were noted at the basement panel which because of this had a dead mouse inside.
- Electrical circuits were not labeled as to their usage. Besides being inconvenient, this prevents us from determining if the circuit, wire, breaker, etc being used is correctly sized for its purpose.

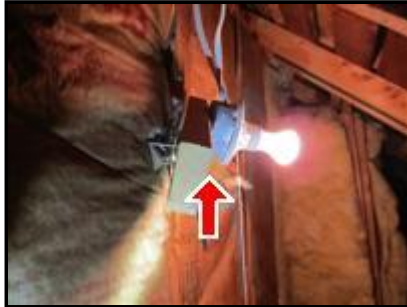
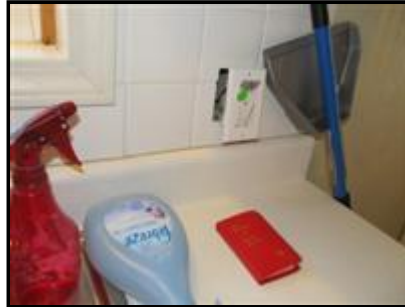
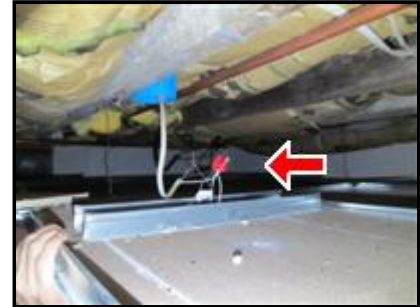
During the examination of the electrical branch circuit we noted we noted deficiencies, such as the following conditions:

- Ungrounded 3-prong electrical outlets at multiple and various locations throughout the home.
- Reversed polarity electrical outlets at multiple various locations throughout the home.
- Loose and unsecured electrical fixtures in the attic, kitchen, etc.
- Improperly terminated wires, open junction boxes, exposed wire splices in the attic and above the basement ceiling tiles, etc.

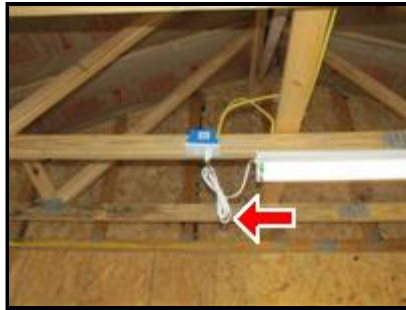
5.7 Picture 1

(5) **FYI** - There were light extension cord(s) being used for permanent wiring at the garage ceiling. This is a common but improper practice.

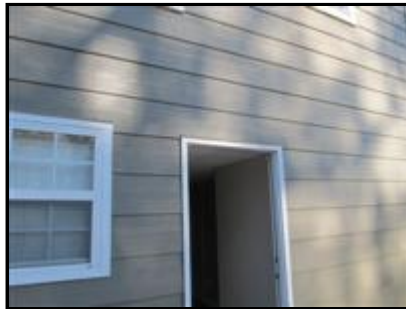
5.7 Picture 2

(6) **FYI** - No light for basement walkout door present. There should be.

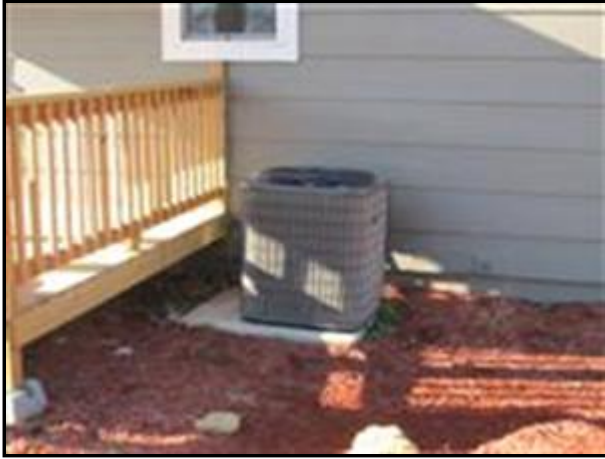
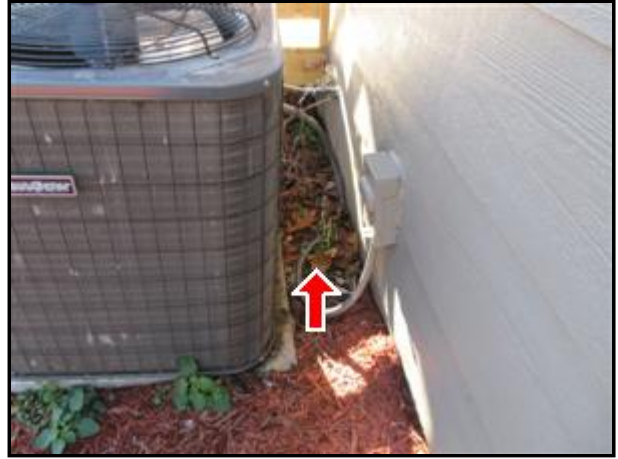
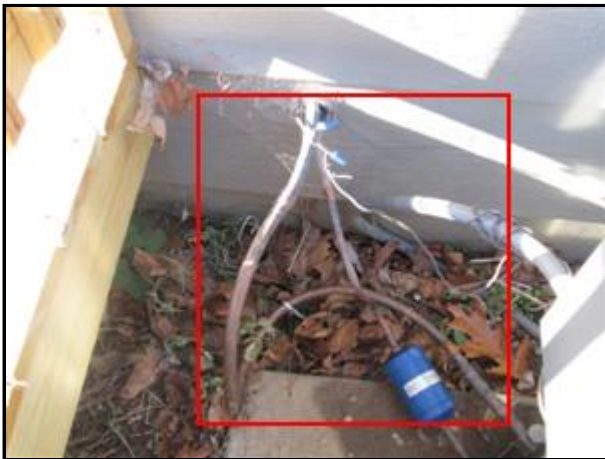
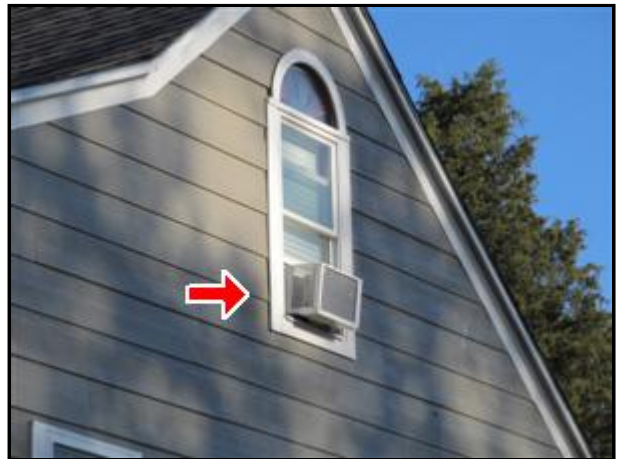
- The disconnect box was partly blocked by the unit [there is to be 36" of space directly in front of an electrical panel].
- The freon line insulation is missing. Outside coils dirty on backside.
- We were **DID NOT** inspect the systems due to outside air temperature being below 60 degrees (operation in cooler weather can damage the compressor).
- Typical service recommended. Clean, service and check the freon levels.

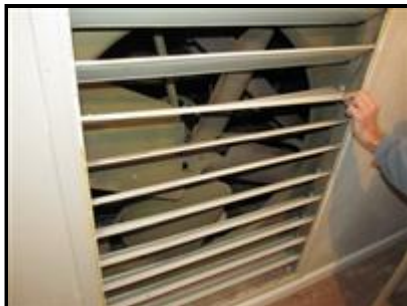
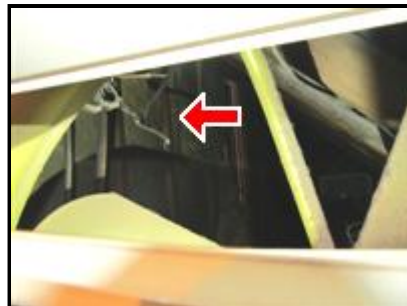
The whole house fan was not operational. It was covered or winterized with a wood cover plate screwed into the wall. Wires were disconnected and not properly terminated (bare wire ends visible). Service and correct.

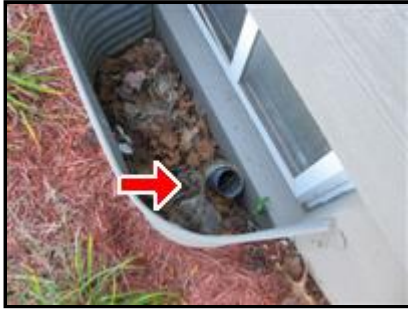
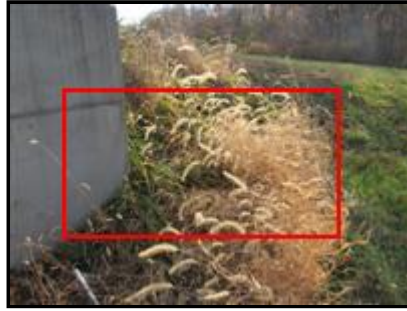
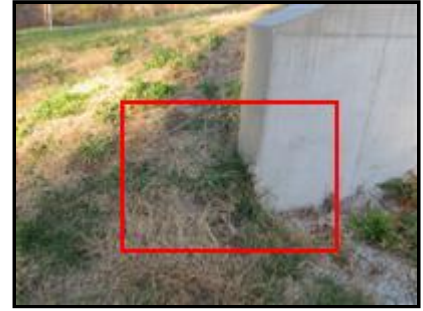
(3) Foundation drain tiles were visible in window well(s), but we did not locate where or if they come to daylight. They need to be uncovered and cleaned out if present. Underground piping is beyond the scope of a visual inspection and not tested. We recommend verifying the correct operation and adequate drainage with the owner prior to closing.

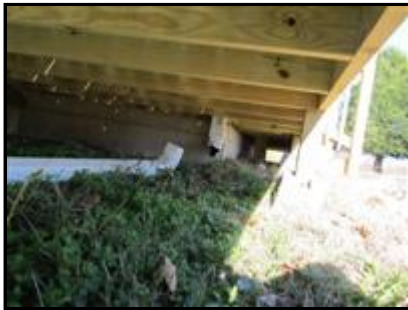
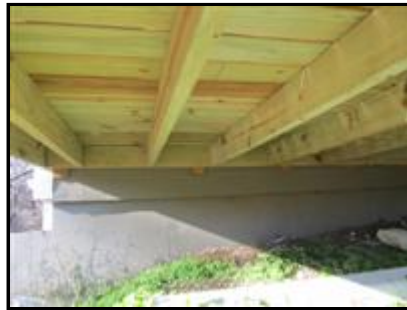
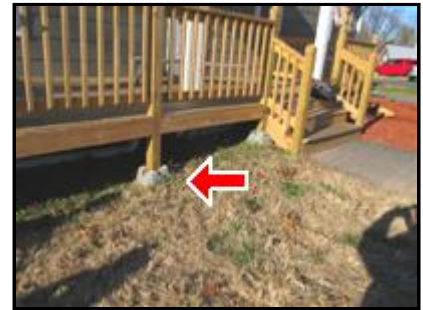
- The deck was not bolted to the building.
- Joist hangers were missing at recommended locations.
- No visible flashing noted at the deck to house wall.
- The post would benefit by installing footings.

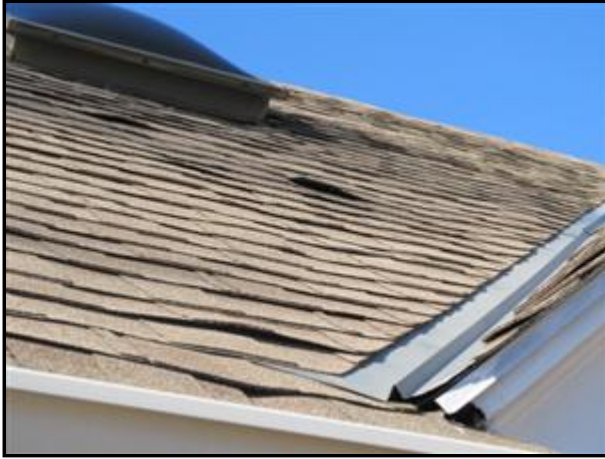
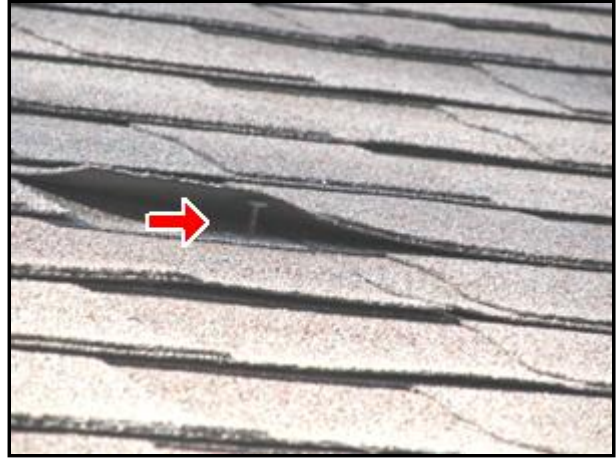
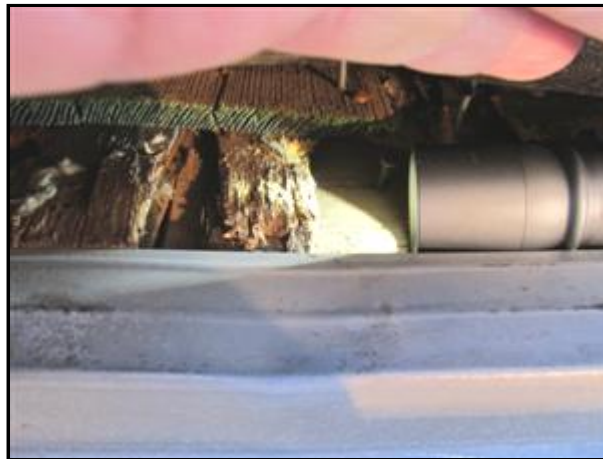
- There were excessively raised shingles at varied locations. It appears some are from nail pops or raised nails.
- The composition roof is installed over older deteriorated wood shingles with no visible felt paper between the layers (we're told some insurance companies frown on this practice - verify this with your company).
- There were some areas noted on the rear roof that had minor deterioration or damage (verify its not hail hits).
- Kickout flashing was not used at gable roof to wall junctions. Minor deterioration to trim boards by rear gable.
- Service as needed and verify insurability / acceptability of roofing with your insurance company prior to close..

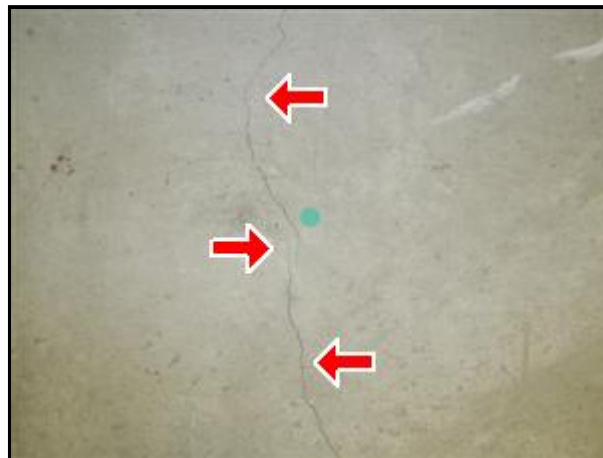
10.0 Picture 1

Minor cracks in the concrete at the foundation walls noted. In our opinion this is typical for this age and type of construction, combined with our expansive soils. However, we always recommend keeping any crack, gap or utility penetration caulked and well sealed to be able to monitor for future movement or leaking. If either condition should ever occur, repairs could be needed.

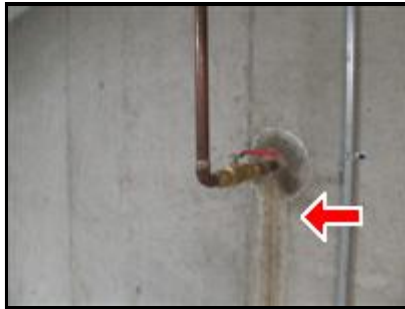
10.6 Picture 1

There were no active moisture leaks noted at the time of our inspection. There is evidence of previous moisture leakage at walls (like by water lines to outside hose bibb. These should be sealed to help prevent water leakage and monitor the areas in the future.

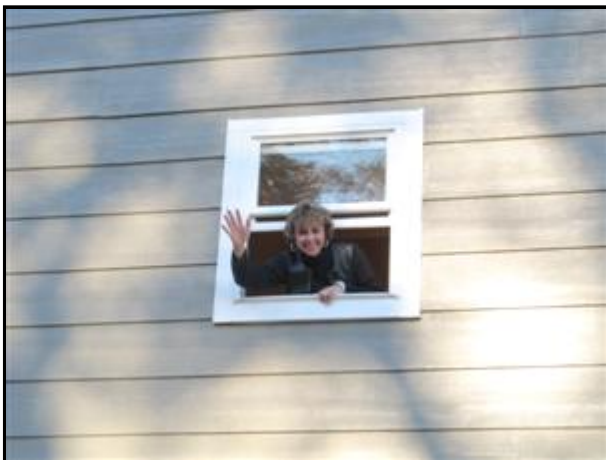
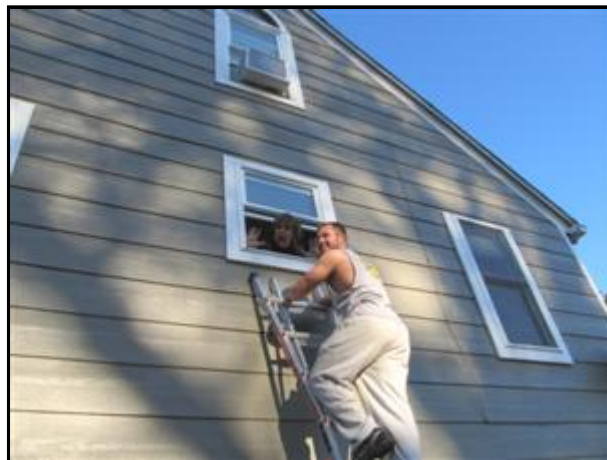
One or more interior doors were missing (like at upstairs rooms). Several doors rub, bind, were missing hardware or for other reasons did not latch properly (basement, front bedroom, 1st floor bathroom). The 1st floor bathroom lock would stick and not open (2 people got stuck in the room during the inspection (unsafe).

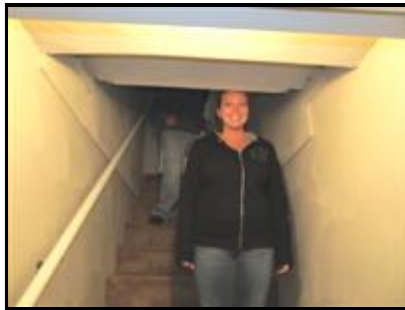
11.6 Picture 1 Example

FYI - Under current safety standards, there was limited headroom over both sets of stairs, which creates a hazard due to the low ceiling height. The steps are steeper than we would build today.

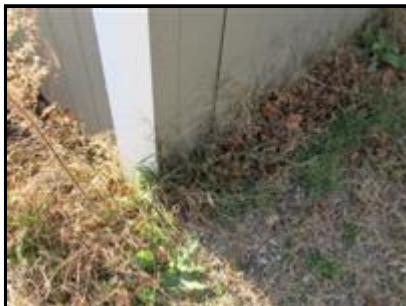
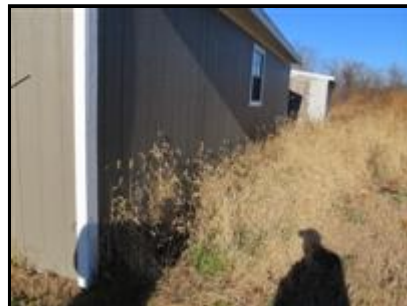
(2) There were at least one or more area(s) where the soil level was too high at the building. Good building practices recommend that there is at least 6" to 8" clearance between the soil and the siding to help prevent moisture damage or pest entry. Regrade the applicable areas as needed.

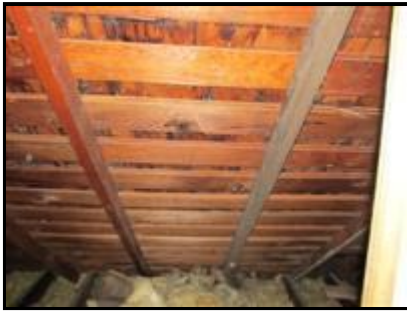
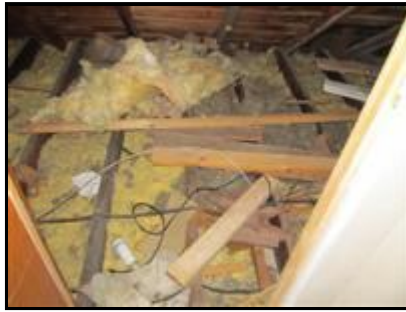
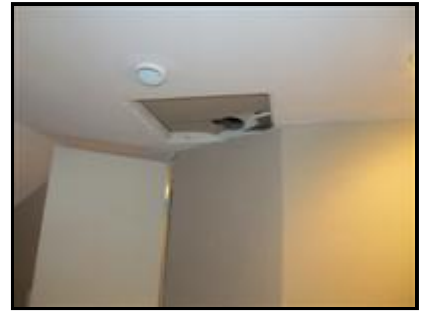
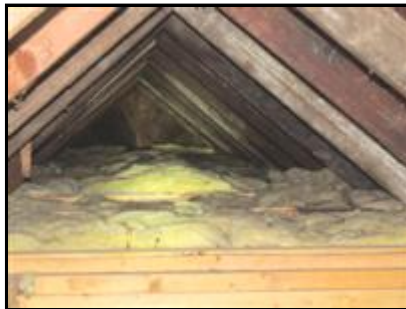
(1) Courtesy view of various attic areas. The access with a ceiling hatch access is damaged (replace it).

There were minor moisture stains in attic that were dry at this time. Monitor this in the future.

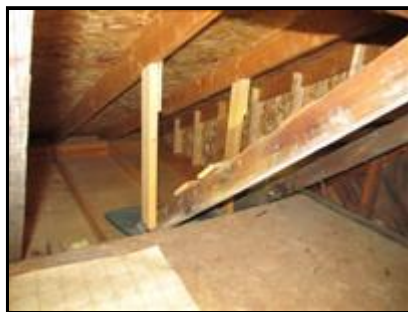
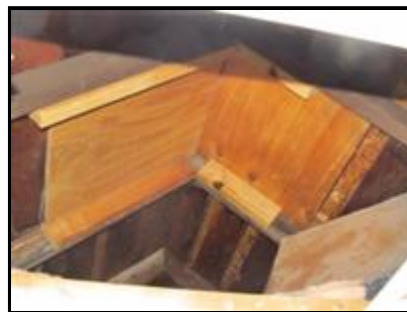
(2) **FYI** - There was minimal attic ventilation. We recommend installing more ventilation for energy efficiency.

FYI - There was minimal insulation installed. We recommend installing more insulation for energy improvement and efficiency.

FYI - Some rafters in the newer front part of the attic have sagged and been repaired or scabbed with short wood blocks. Also older repairs noted at roof decking.

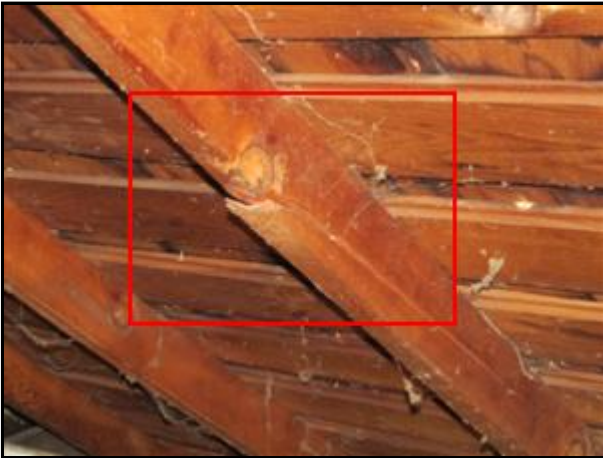
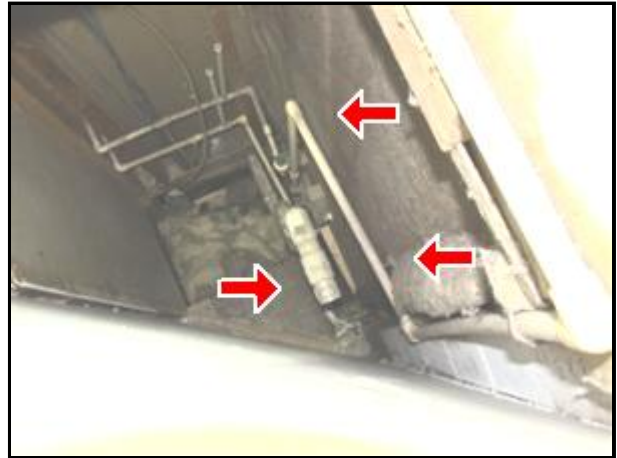
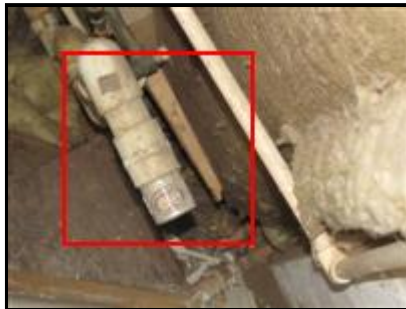
- It looks like the plumbing vent for 2nd floor bath terminate in the attic chase cavity. This is improper and if still in use they should be extended to the exterior to get sewer gas odors, etc outside and prevent possible freeze-ups..
- We saw at least one or more cracked and broken roof rafter.

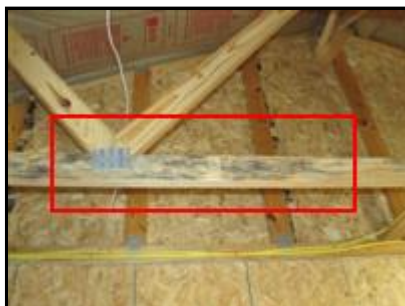
13.4 Picture 1

We noted what in our opinion looks like construction mold. It is not uncommon for this type to have been present since the structure was built and is not typically harmful. Mold types and its significance can only be discovered through sampling and laboratory analysis. Monitor this for new growth. If new growth is noted or if you are concerned about potential health concerns, get this sampled or tested by a mold or air quality specialist. We **DID NOT** perform any mold tests or mold / air sampling or testing at this property. A visual inspection alone can not verify the absence or presence of mold.
