Inspection Report

Property Address:
516 NW 2871st Rd
Kingsville MO 64061

Holmes Inspection Company

Date: 12/20/2016	Time: 1:30:07 PM	Report ID: 09997-Copy
Property: 516 NW 2871st Rd Kingsville MO 64061	Customer: Jamie Smith	Real Estate Professional: NONE

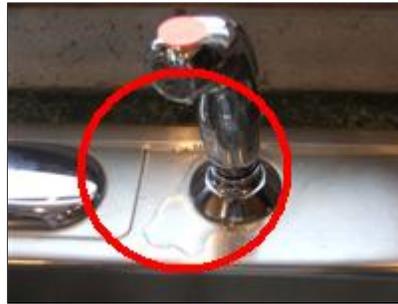
1.1 Picture 1

(1) The sink spray wand is leaking.

(1) The sink spray wand is leaking.

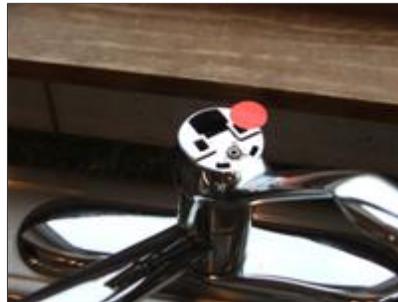
1.1 Picture 2

(2) **FYI** - The trim piece on top of the faucet is gone.

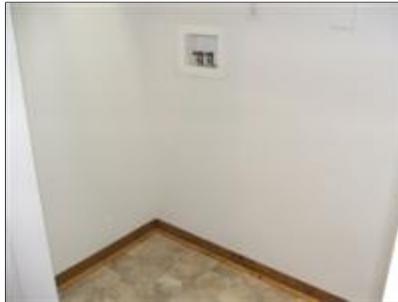
1.7 Picture 1

FYI - The laundry equipment will be installed on a finished floor. Installing a watertight "drain pan" under the washer would be a beneficial improvement, to help prevent any moisture damages if the unit should leak.

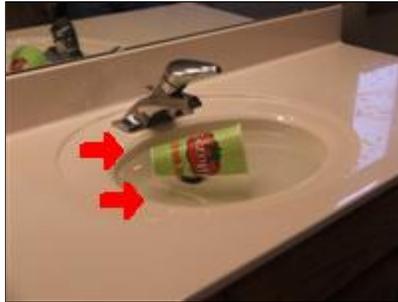
2.1 Picture 1

The master vanity sink drains very slowly and appeared clogged. Service and Repair.

The master vanity sink drains very slowly and appeared clogged. Service and Repair.

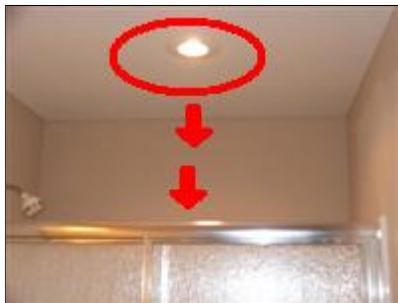
2.6 Picture 1

For Safety - The can lights over the showers in both bathrooms should have a protective lens to prevent glass from falling in the shower or tub area in case the bulb breaks. Or they should be completely outside the zone that could allow falling glass to get into the tub/shower enclosures. Service and Correct.

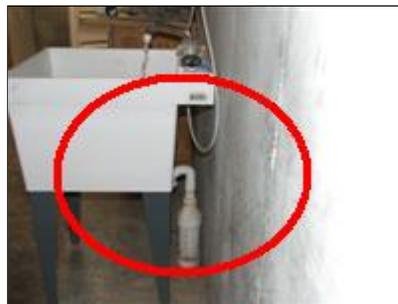
3.2 Picture 1

There is an improper "S-Trap" at the basement sink. These are typically not connected to the venting system for the building and can allow sewer gas back into the fixture, let the trap go dry, allow slow draining, etc. Although commonly seen in older homes, this type of trap has not been allowed by plumbing codes for over 20 years. This could be corrected by installing an "AAV" (air admittance valve) at this location. This was discussed with the buyer on site.

There is an improper "S-Trap" at the basement sink. These are typically not connected to the venting system for the building and can allow sewer gas back into the fixture, let the trap go dry, allow slow draining, etc. Although commonly seen in older homes, this type of trap has not been allowed by plumbing codes for over 20 years. This could be corrected by installing an "AAV" (air admittance valve) at this location. This was discussed with the buyer on site.

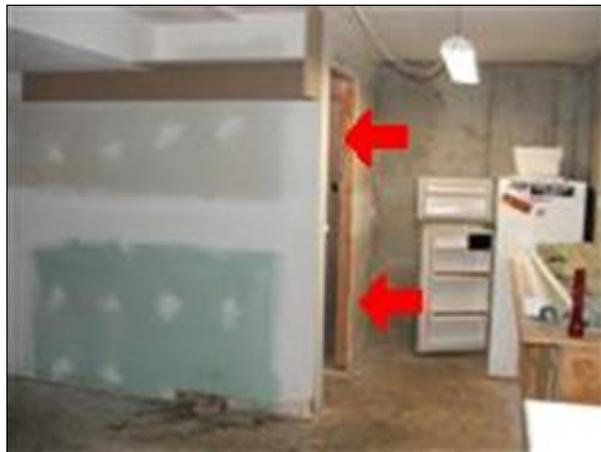
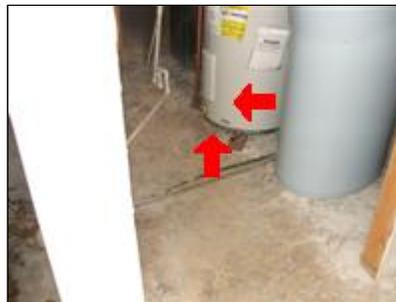
3.4 Picture 1 Separation Wall

(1) The water heater is installed in the basement garage directly on the floor. There is a separation wall to protect it from direct vehicular impact, but there are no doors, wall, etc to close it off from the garage. As is, the lower heating element has potential exposure to combustion sources - AND - under current safety standards it should not. Due to the

location, we recommend installing a wall and/or door(s) with self-sealing thresholds at the 2 openings that go from the garage to the water heater area.

(1) The water heater is installed in the basement garage directly on the floor. There is a separation wall to protect it from direct vehicular impact, but there are no doors, wall, etc to close it off from the garage. As is, the lower heating element has potential exposure to combustion sources - AND - under current safety standards it should not. Due to the location, we recommend installing a wall and/or door(s) with self-sealing thresholds at the 2 openings that go from the garage to the water heater area.

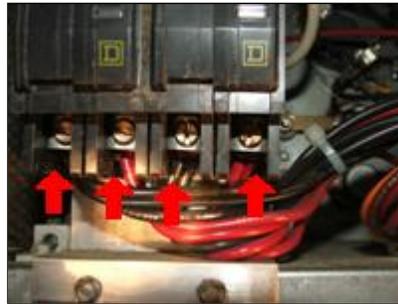
4.0 Picture 1

The installer has put multiple wires on each connection on the heat strip breakers inside the electric furnace. This is a common but improper wiring practice as its very hard to get the same amount of torque on the wire under the screw when there are multiple wires under the screw. HVAC contractor to correct.

The installer has put multiple wires on each connection on the heat strip breakers inside the electric furnace. This is a common but improper wiring practice as its very hard to get the same amount of torque on the wire under the screw when there are multiple wires under the screw. HVAC contractor to correct.

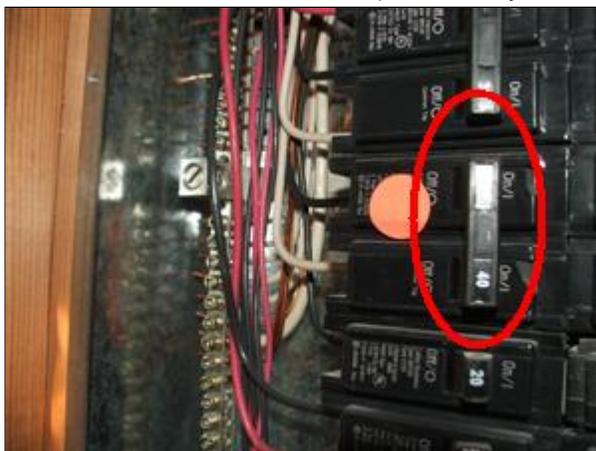
5.1 Picture 2

(2) The breaker for the A/C unit does not match its data tag. The data tag says the maximum size should be 30 Amp. The breaker is a 50 Amp. We recommend a licensed electrician repair / modify as needed.

(2) The breaker for the A/C unit does not match its data tag. The data tag says the maximum size should be 30 Amp. The breaker is a 50 Amp. We recommend a licensed electrician repair / modify as needed.

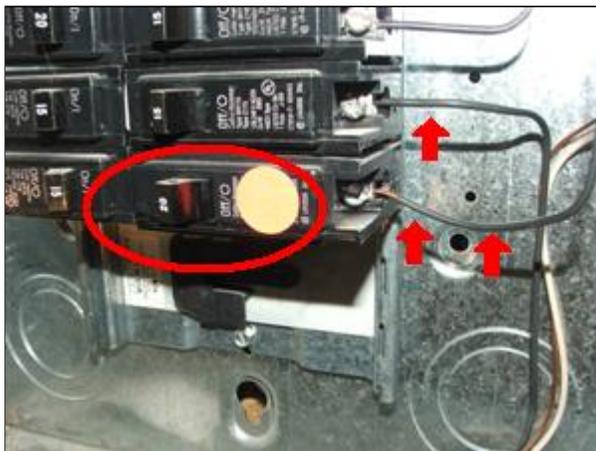
5.1 Picture 3

(3) One or more of the breakers was oversized for the wiring it controls. (Example - the bottom breaker is a 20 Amp breaker and the wires going to it appear to be the same size as those on the 15 Amp breaker above it. Have your electrician verify which is correct - then repair as needed.

(3) One or more of the breakers was oversized for the wiring it controls. (Example - the bottom breaker is a 20 Amp breaker and the wires going to it appear to be the same size as those on the 15 Amp breaker above it. Have your electrician verify which is correct - then repair as needed.

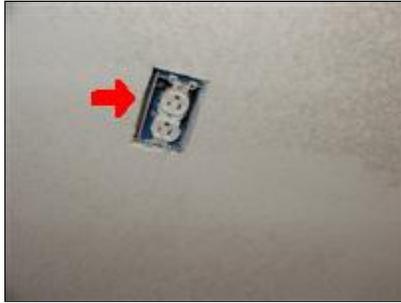
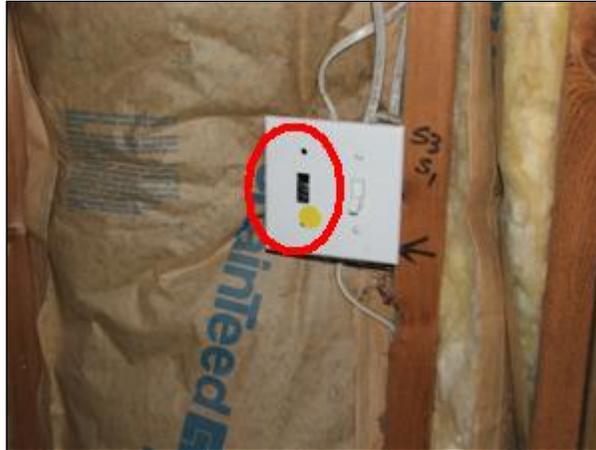
5.2 Picture 1 Garage Ceiling

(1) We noted missing cover plate(s) and outlet cover with exposed wiring at a few places in the basement area. Correct as needed.

(1) We noted missing cover plate(s) and outlet cover with exposed wiring at a few places in the basement area. Correct as needed.

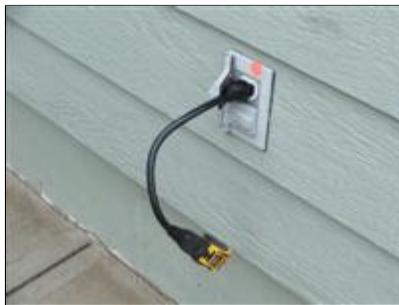
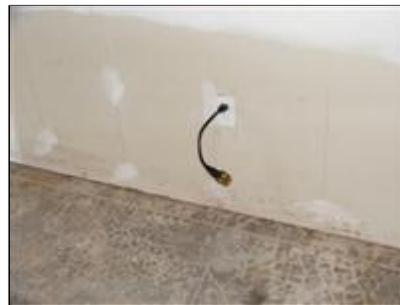
5.2 Picture 3 Outside Front

(2) Under current safety standards and building codes, a Ground Fault Circuit Interrupter (GFCI) is recommended at electrical outlets in "all wet areas" such as: bathrooms, kitchens, garages, wet bars, the exterior, unfinished basements, etc. **MANY** of these type locations at this property lack proper GFCI protection (such as the front outside electrical outlets, the upper garage outlets, 1 outlet at the kitchen counter-top right of the range, the lower garage, and most of those in the unfinished basement). A licensed electrician should install these at all applicable areas.

(2) Under current safety standards and building codes, a Ground Fault Circuit Interrupter (GFCI) is recommended at electrical outlets in "all wet areas" such as: bathrooms, kitchens, garages, wet bars, the exterior, unfinished basements, etc. **MANY** of these type locations at this property lack proper GFCI protection (such as the front outside electrical outlets, the upper garage outlets, 1 outlet at the kitchen counter-top right of the range, the lower garage, and most of those in the unfinished basement). A licensed electrician should install these at all applicable areas.

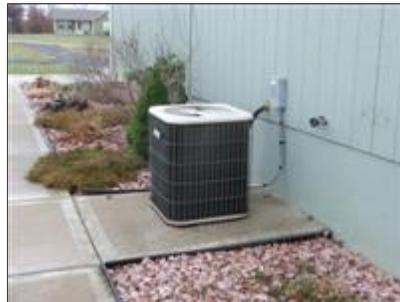
6.0 Picture 1

The exterior condensing unit coils are clogged with dirt and debris. The electrical disconnect is directly behind the unit with less than 12" clearance. Improper location and clearance.

HVAC contractor to Service and Correct.

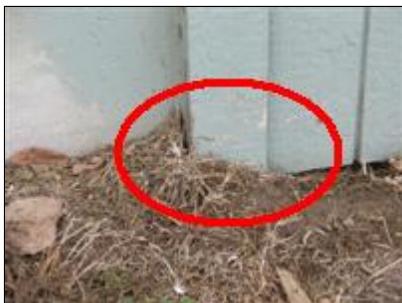
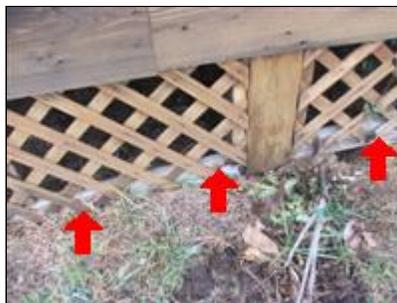
7.3 Picture 1

The soil or landscaping material was in contact with the siding or wood portions of the structure at the rear siding at 1 locations and the deck lattice This can lead to moisture intrusion, rot or termite entry at the structure or its components. Regrade the applicable areas as needed.

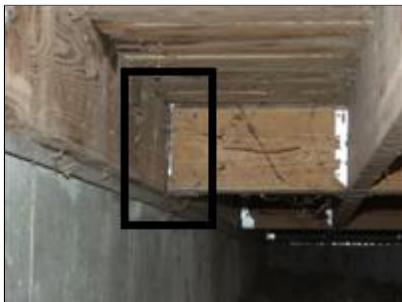
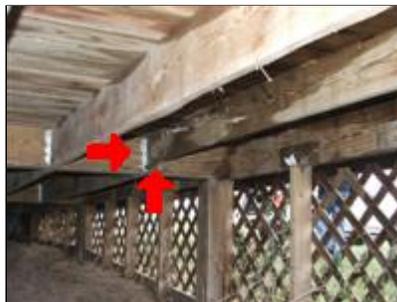
7.4 Picture 1 Missing Joist Hanger

(2) Joist hangers and lag bolts were missing at multiple locations under the front deck, and 1 joist was too small so someone has put spacer blocks in the joist hanger. Modify and Repair both conditions.

(2) Joist hangers and lag bolts were missing at multiple locations under the front deck, and 1 joist was too small so someone has put spacer blocks in the joist hanger. Modify and Repair both conditions.

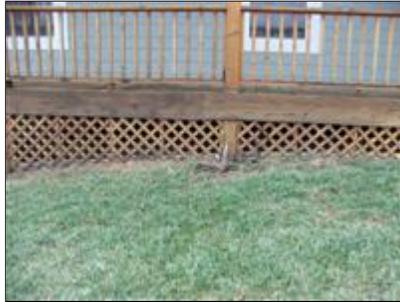
7.4 Picture 3

(3) **NOT INSPECTED:** Courtesy view of front porch / deck. We were unable to inspect under the deck / porch due to it being very low to the ground and the sides being lattice covered. Recommend removing lattice so the underside can be inspected.

(3) **NOT INSPECTED:** Courtesy view of front porch / deck. We were unable to inspect under the deck / porch due to it being very low to the ground and the sides being lattice covered. Recommend removing lattice so the underside can be inspected.

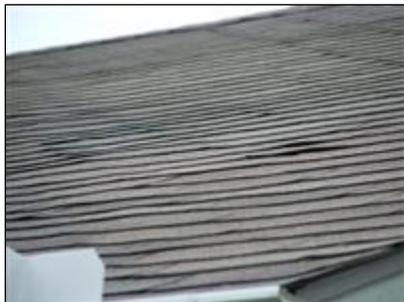
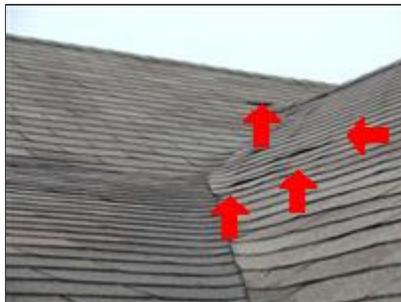
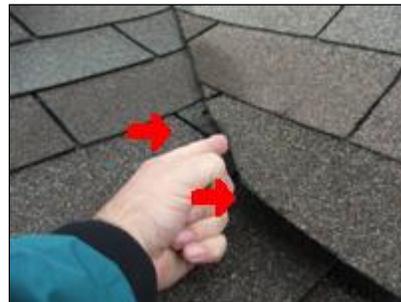
8.0 Picture 1 Raised Shingles

There were missing shingles and raised shingles (some the ends were not sealing down - others caused by nail pops). The valley had missing sealant. Typical service and maintenance is recommended for the shingle roof. This should help ensure the water tightness of the structure and should be done on a regular basis.

There were missing shingles and raised shingles (some the ends were not sealing down - others caused by nail pops). The valley had missing sealant. Typical service and maintenance is recommended for the shingle roof. This should help ensure the water tightness of the structure and should be done on a regular basis.

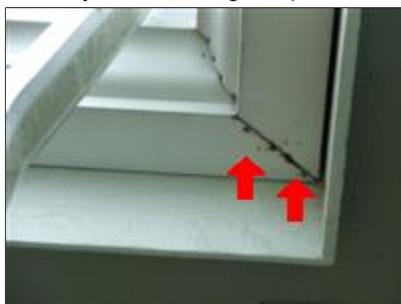
8.2 Picture 1

During the rain the seam at the front over the entry was leaking. Repair as needed.

During the rain the seam at the front over the entry was leaking. Repair as needed.

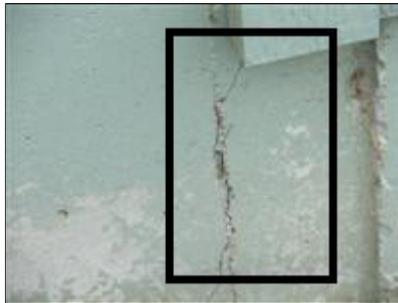
9.0 Picture 1 Rear of House

Small cracks at the foundations wall was noted. In our opinion this is not uncommon for the location (step down in wall), type of construction, and our local soils. Keep sealed to monitor them in the future.

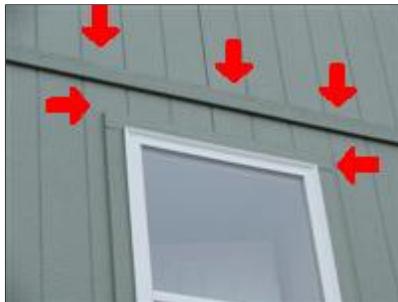
9.2 Picture 1

Flashings were not present at all locations. Install flashing and keep these areas well caulked and sealed.

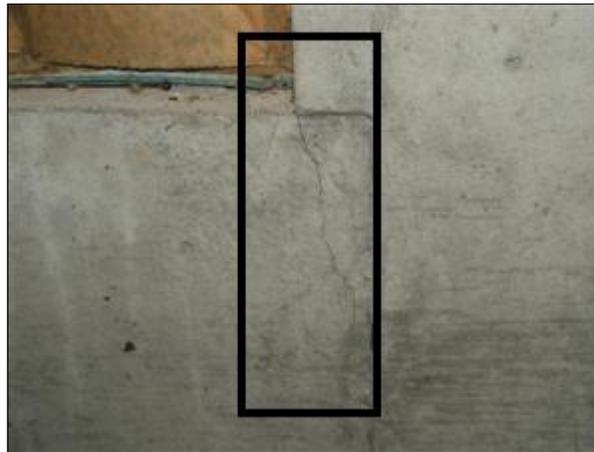
10.0 Picture 1

Small cracks at the foundations wall was noted. In our opinion this is not uncommon for this location, type of construction, our local soils and is not structurally significant. Keep them sealed to monitor them in the future.

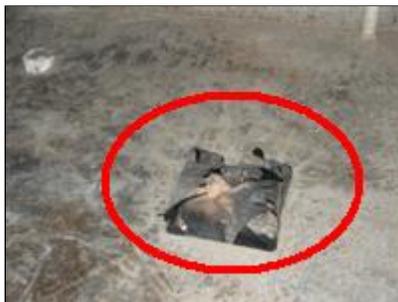
10.7 Picture 1

The home has a walk-out basement so a sump pump is not mandated by building codes. There is a gravel lined pit present. It may house a clean-out for plumbing OR it may be to relief pressure from any water that gets trapped below the floor slab. You may want dig in the gravel to verify what's in there if anything.

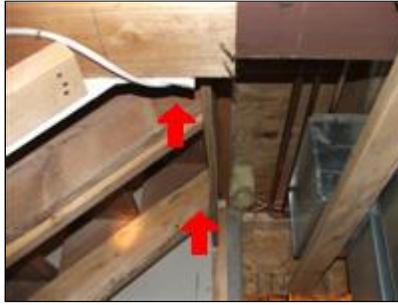
10.8 Picture 1

The basement stairs bounce. The stringers at the top don't reach the rim joist, so they are nailed to a piece of plywood hanging from the rim joists. To stabilize the stairs, a support across the top or a post under them (at the top) could be easily installed. This was discussed with the buyer on site.

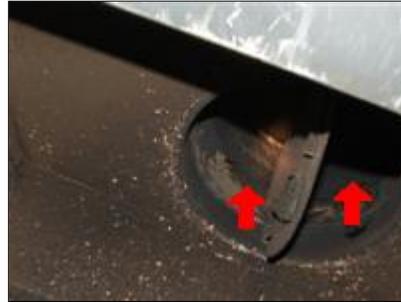
11.7 Picture 2 Creosote in Flue

Creosote was visible in part of the metal flue. The flue was not fully visible. Although we attempt to determine if they are dirty or not, most flues are not fully visible and are therefore not inspected during a visual home inspection. We recommend having this cleaned and checked prior to closing by a certified chimney sweep.

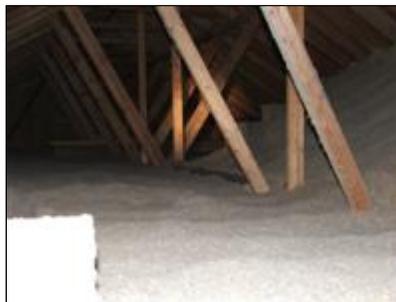
12.6 Picture 1

Courtesy view of attic. There were minor moisture stains in attic that were dry at this time. Monitor this in the future. We recommend adding more insulation for energy efficiency.

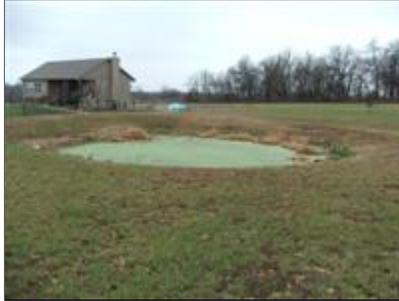
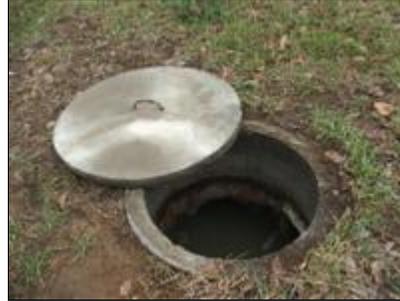
13.0 Picture 1

(1) A private waste system was present. We are not licensed septic inspectors and no destructive or intrusive septic system or lagoon testing was performed by this company. It is our understanding that state or federal standards recommend certain things like fencing around a lagoon, that this one did not have.

(1) A private waste system was present. We are not licensed septic inspectors and no destructive or intrusive septic system or lagoon testing was performed by this company. It is our understanding that state or federal standards recommend certain things like fencing around a lagoon, that this one did not have.

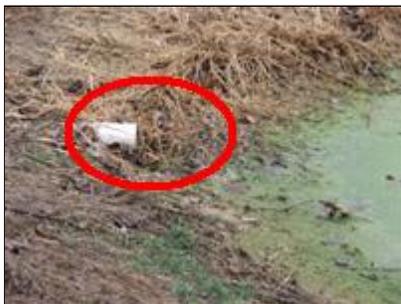
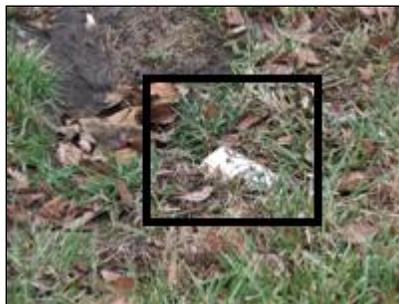
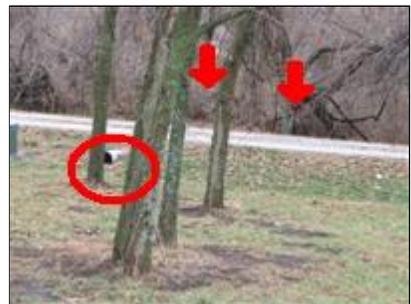
13.0 Picture 3 Overflow Tube in Lagoon

(2) The lagoon had an overflow pipe inside its banks, that passed through the "Bern" then looked like if it was in use it would filter downhill to what appears to be a community storm type drain going to a dry creek bed or causeway. Your septic contractor can evaluate this and determine if it is a health issue or not.

A licensed septic contractor can provide testing on the system installation, test the waste disposal system, and verify the correct operation and proper performance of the system

(2) The lagoon had an overflow pipe inside its banks, that passed through the "Bern" then looked like if it was in use it would filter downhill to what appears to be a community storm type drain going to a dry creek bed or causeway. Your septic contractor can evaluate this and determine if it is a health issue or not.
